Morwell

(88 miles 75 chains 47 links, 144.372 km)

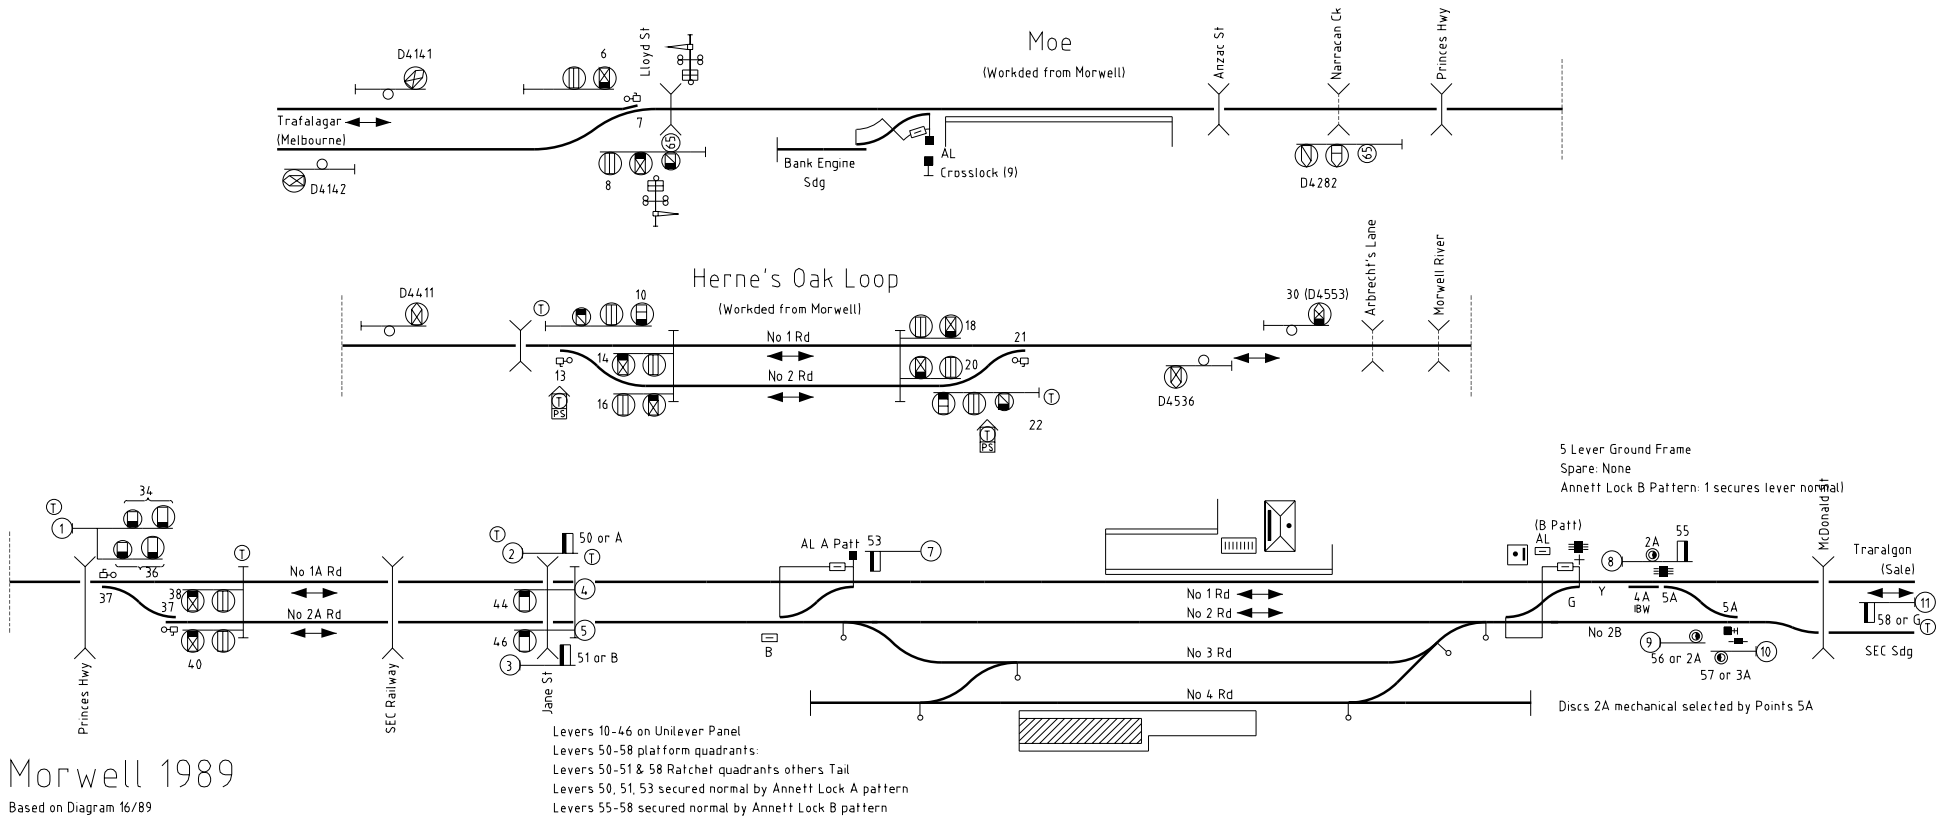
Morwell 1966

Based on Box Diagram dated B.3.66, Locking Sketch RB608, & Signalling Diagram 17'66

- 03.07.1966 Automatic and Track Control system of working provided on the sections Moe - Herne's Oak - Morwell and the Electric Staff system and Temporary Train Staffs abolished. No 2 Road at Morwell extended 1 mile 294 yards in the Up direction. Panel provided at Morwell to work Herne's Oak loop and Up end of No 2A Road. Quadrant levers on platform relocated to the new signal bay adjacent to the Station Office. Diagram 4/65 replaced 7/50. (WN 28)
- 07.09.1968 Last Mirboo Nth DRC ran on this Saturday. Line closed for passengers as from 9.9 (WTT, WN 35 extracts, Sec 67/4909)
- 10.04.1969 Plunger locked Points G rodded to points in No 2 Road and worked by small point lever (CI)
- 21.07.1971 Hand gates provided at Commercial Road (89 miles 11 chains). The signalman must receive a signal from the traffic branch employee operating the gates that they have been opened

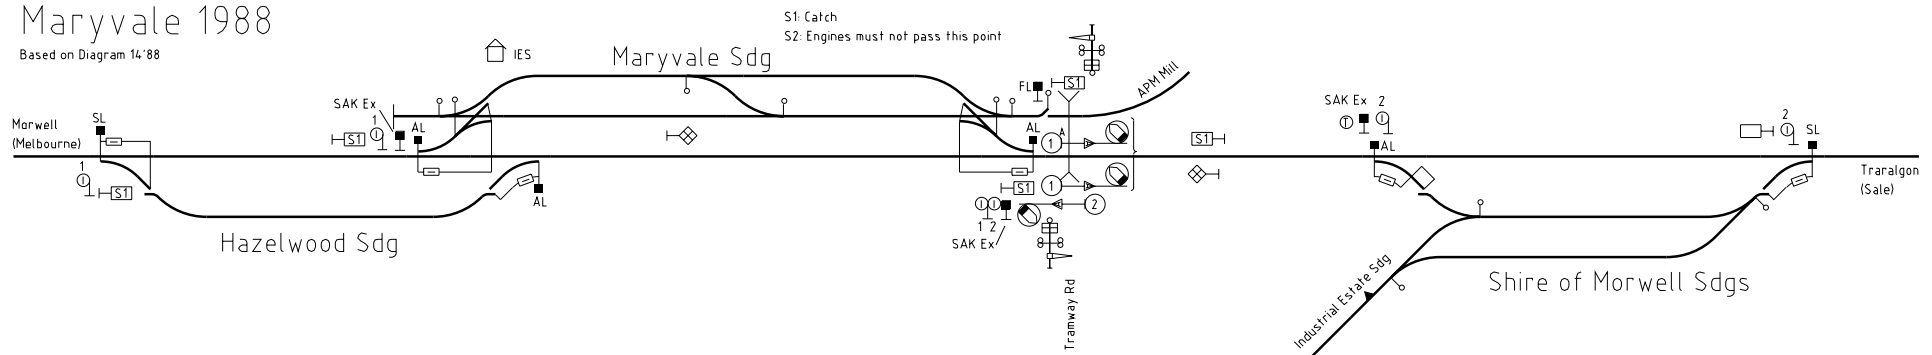
Maryvale 1988

Based on Diagram 14'88
