# Pakenham

(35 miles 31 chains 49 links, 58.193 km)

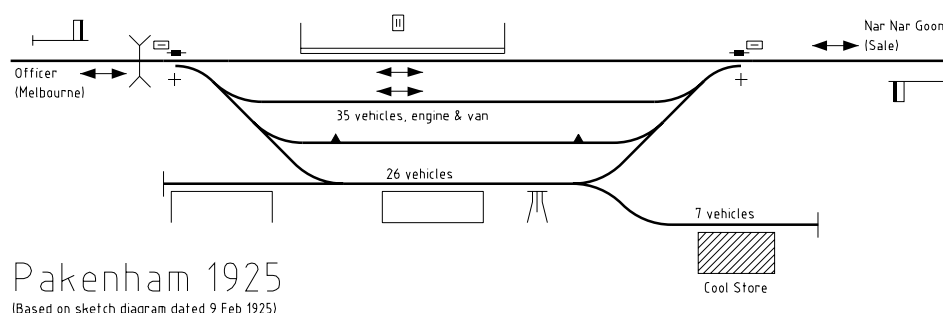
- 07.01.1910 Up and Down main line points fitted with plunger locks. Two sets provided (WN 2, Special Locks Register 1)

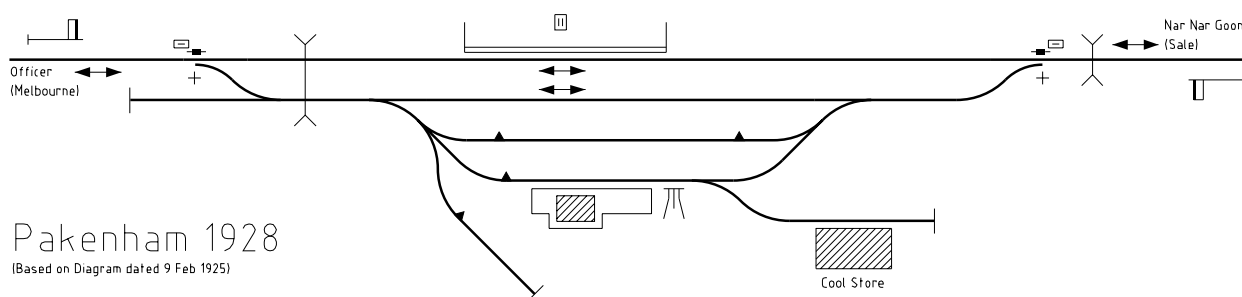
- 21.03.1928 Up Home relocated 290 yards further out (WN 13)
- 28.03.1928 Down Home relocated 110 yards further out (WN 14)
- 18.04.1928 No 2 Road extended to hold 60 vehicles; mainly at Down end, but extended to dead end at Up end. (WN 22, 26/20066)

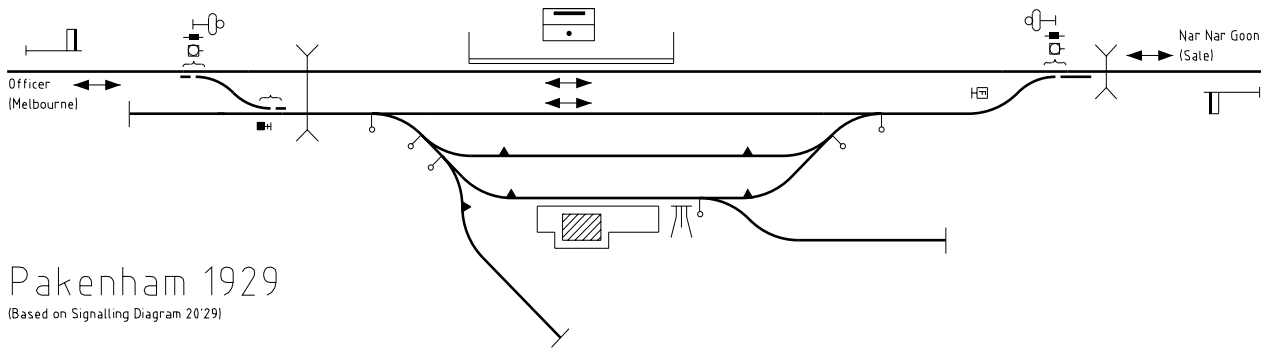
Pakenham 1929

03.10.1929 Main line points at each end equipped with double wire operation, lockbar, and switchstand. Ten lever double wire frame provided on platform to work Up and Down main line points and Home signals. (2 point levers, 2 signal levers, 6 spare levers). Diagram 20/29 provided. (WN 43, IR)

(Based on Signalling Diagram 20/29)

- (15.10.1929) Instructions for double wire operation published. Fouling point indicator showing an illuminated letter 'F' provided where No 2 Road is a loop. Where there is a dead end extension of No 2 Road, an ordinary point indicator is provided on points and is to be treated as a fouling point indicator. Short sections of track from points fouling points in No 1 & 2 Roads fitted with track circuit operating indicator at box. Indicator shows red light when track occupied and white light when clear. Switch stands show (in both directions) lunar white light/two green discs when set for No 1 Road, and yellow arrow/yellow light when set for No 2 Road. For arriving moves into No 2 Road, Home must not be cleared until train has been checked. When train arrives complete, Guard must signal to Signalman to indicate train is complete (WN 42)

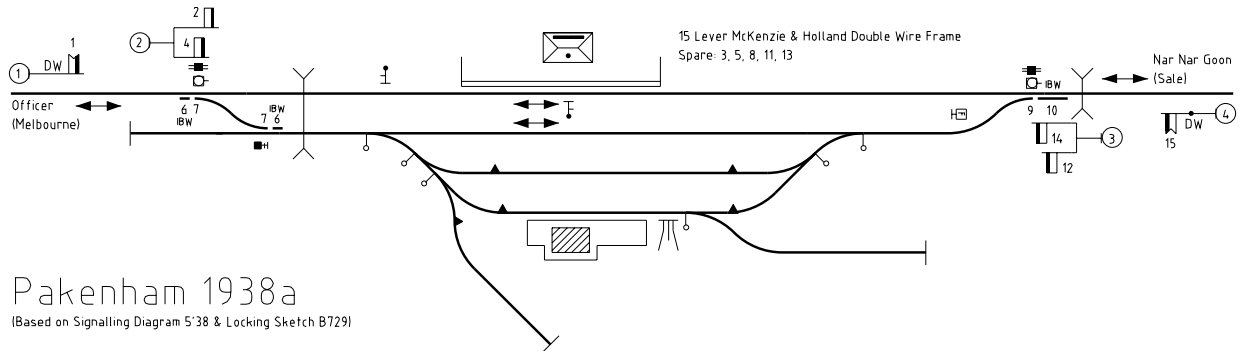
Pakenham 1938a

- 17.03.1938 Up and Down Distant signals provided. Switch stands removed from main line points and homes provided for moves into No 2 Road. New 15 lever double wire frame provided with 6 signal levers, 2 point levers, & 2 lockbar levers. Diagram 5/38 replaced 20/29. (WN 14, IR, AGST 11/405/5)

(Based on Signalling Diagram 5/38 & Locking Sketch B729)

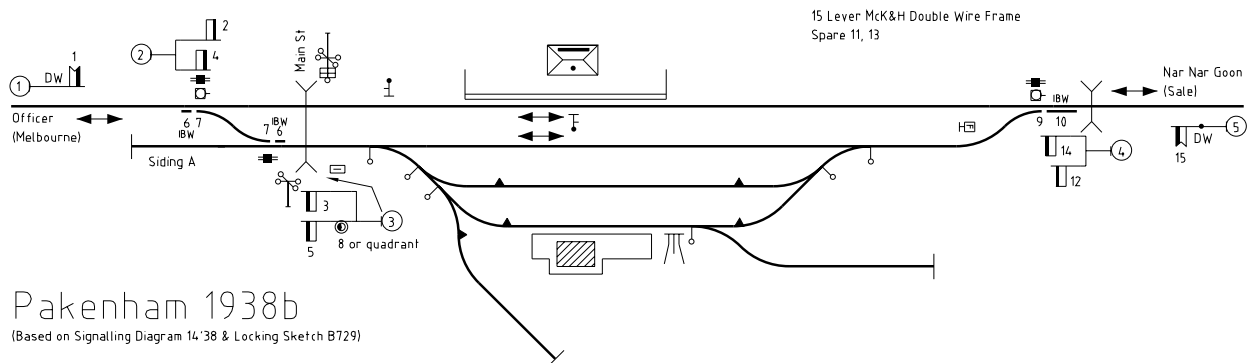
Pakenham 1938b

20.12.1938 Flashing lights provided at Main Street (35 miles 25 chains) at Up end of station. New bracket Post 3 provided with two homes and one disc. Additional 3 signal levers provided in frame. Diagram 14/38 replaced 5/38. (WN 1, IR, AGST 12/80/2)

(Based on Signalling Diagram 14/38 & Locking Sketch B729)

- (25.01.1939) To prevent unnecessary operation of the flashing lights, the Up Departure Home must not be placed to proceed for an Up train required to stand at platform for more than the usual time until train is quite ready to depart. Bell provided in office and will ring when flashing lights are operating. To indicate failure of the lights (Station Scrapbook)

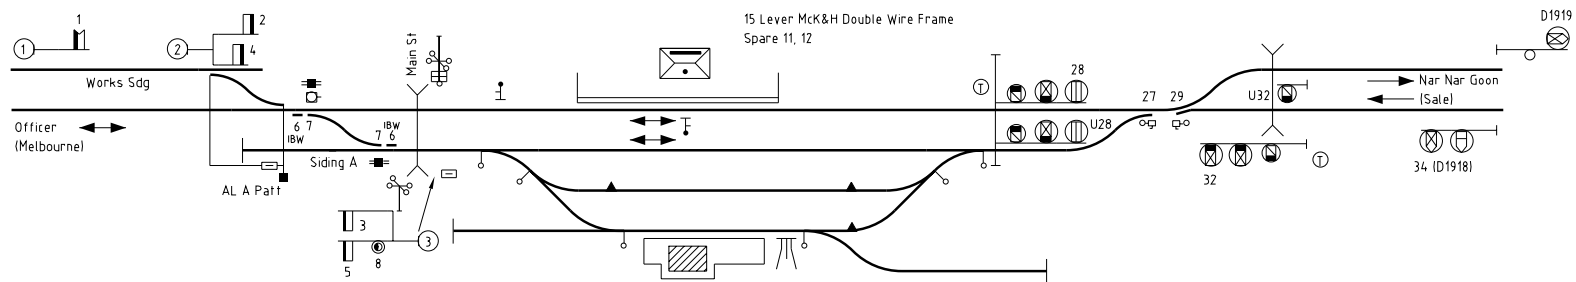
Pakenham 1954a  
 (Based on Signalling Diagram 3'54 & Box Diagram dated 6.10.54)

- 19.12.1954 Three Position Automatic Signalling. Mechanical signalling at Down end replaced by three position signals and motor points worked by a control panel. Diagram 3/54 replaced 14/38. (WN 42, IR, ACTM 19/272/4)
- Works Siding at Up end became Main Line. Mechanical points and signals at Up end replaced by three position signals and motor operated points. Panel took control of entire station and double wire frame abolished. Post 1 replaced by Automatic D1799. Post 2 replaced by three position Home 6. Crossover 7 replaced by new crossover worked by lever 9 slightly further out. Post 3 replaced by three position Homes 12 (from No 2 Road) and 14 (from No 1 Road) on signal bridge. Diagram 8/54 replaced 3/54 (WN 1, IR, ACTM 19/290/5)

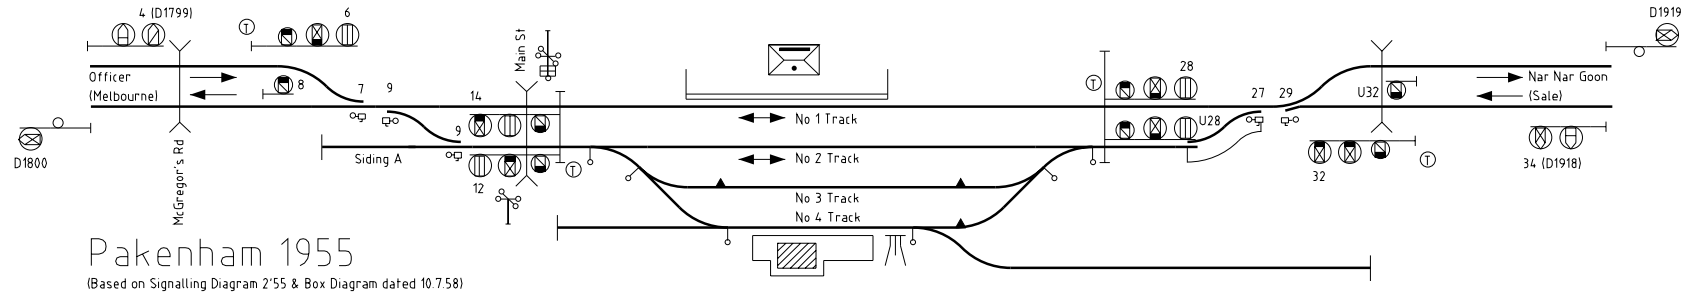
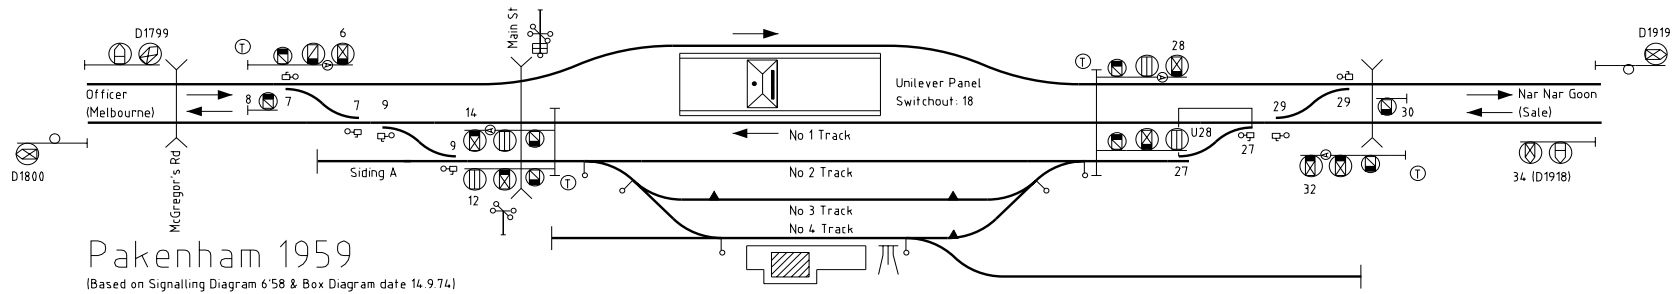
- 12.12.1974 Flashing lights provided at Racecourse Rd (57 km 519 m) at Down end (WN 2)
- 19.01.1975 No 1 Track signalled for bi-directional running. Locking altered so that Home 6 can clear for running moves to No 1 Track; medium speed aspect will apply for No 1 Track or Down Main line. New Down Home 24 provided for moves from No 1 Track to Down line. Diagram 17/74 replaced 6/58. (WN 4, IR)

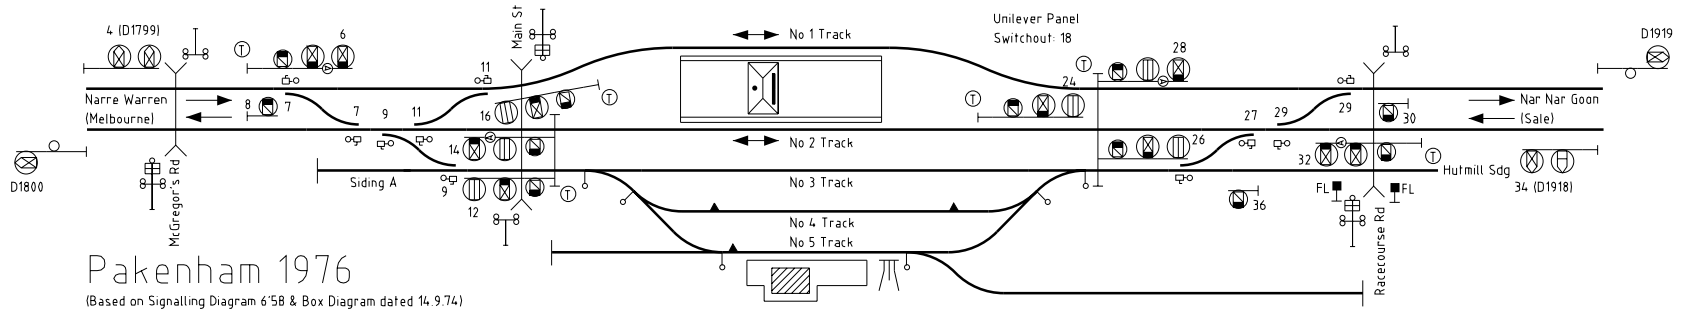
| <p>13.04.1975 Down platform signalled for terminating trains. New Crossover 11 provided, together with Up Home 16. Down Automatic D1799 again controlled by lever 4. Dwarf 30 altered to apply to all roads. Tracks renumbered. Diagram 2/75 replaced 17/74. (WN 16, IR)</p> <p>14.04.1975 Main St flashing lights improved (2 additional masts provided). (CI)</p> <p>18.05.1975 Down Home 6 relocated 200 feet in the Up direction (WN 21)</p> <p>16.09.1976 Hutmill Siding (Robert Hutchinson Ltd) provided. Leads from No 3 Track and crosses Racecourse Road. The siding is 645 metres long with a loop with standing room of 170 metres at end of siding. Electrified to Up side of weighbridge. Catch 27 replaced by points.</p> | <p>28.06.1984 Train Stops provided at Automatic signals between Officer and Pakenham (including D1799 &amp; D1800), and Homes 6, 14, 16, 24, and 28 (WN 27)</p> <p>06.09.1986 Boom barriers provided at McGregor Rd and Main Street. Controlled Automatic D1824 (lever 10) provided at McGregor's Rd. Signals 6, 8, 12, 14, and 16 are interlocked with the Main Street boom barrier cycle. Up Express/Stopping buttons provided interlocked with Homes 14 (&amp; 16?). Push button provided for selecting Up Goods trains which will shunt at</p> | <p>04.09.1988 Shunting selection button for Officer abolished (WN 36)</p> <p>11.12.1988 Siding A was abolished. Points 9D converted to Catch points (WN 50)</p> <p>10.11.1991 Down Home 6 relocated 100 metres in the Up direction (WN 41)</p> <p>25.03.1995 Control of line between Dandenong and Pakenham transferred from Centrol to Metrol (WN ?)</p> |

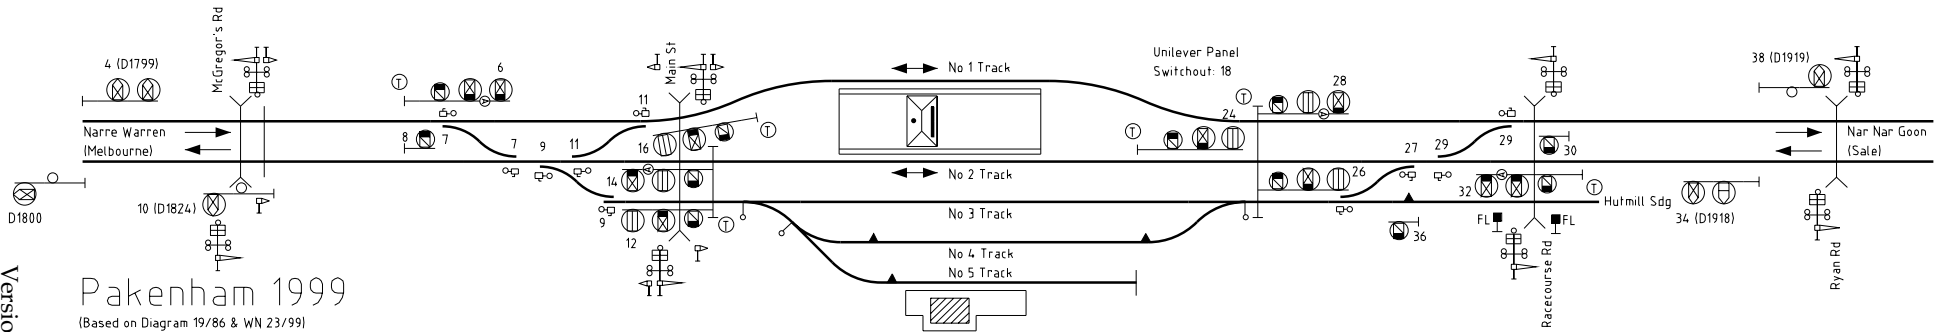
Pakenham 1999  
(Based on Diagram 19/86 & WN 23/99)

- 31.05.1998 Hand points leading to No 5 Track at Down end. No 5 Track now a dead end and will be extended 15 metres in Down direction. (WN 21)
- 23.05.1999 Boom barriers provided at Racecourse Road (58.751 km) and Ryan Road (60.534 km) on Down side of station. Down Automatic D1919 converted to Controlled Automatic (lever 38) to prevent Ryan Road from operating during shunting. Express/Stopping selection provided for Down trains. Home 28 must be operated before selecting class of train (WN 21)

- 09.12.1999 Flag Derails replaced existing Derail at Up and Down ends of No 4 Track and Up end of No 5 Track. Derail at Down end of No 4 Track relocated 50 metres further out, and Derail at Up end of No 5 Track relocated 10 metres further out. An additional flag derail provided in No 3 Track on Down side of Crossover 27. (WN 50)
